**Flood Control Project Maintenance
Levee Inspections**
LMA District Cover Sheet
Spring 2018 Levee Inspection Results

Eastern Honcut Creek

**Flood Control Project Maintenance
Levee Inspections
Unit Cover Sheet
Spring 2018 Levee Inspection Results
Eastern Honcut Creek**

Levee Inspection Report By Mile - Spring 2018

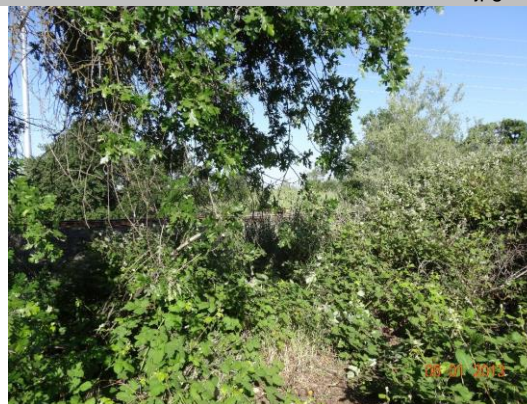
Photo 2 of 3 : UCIP_SP_2018_14731_24225.jpg

LM Start	0.01	Rating **	M	Issue No.	27
LM End	0.01	Issue Type +	Ma	Location *	
Category	Supplemental			GPS Latitude/Longitude	
				Start	End
Item	DWR UCIP LMA Responsibility			39.298484 °	39.298484 °
				-121.569610 °	-121.569610 °
DWR ID					
Comment Code					
Inspector Comment					
FS_ID:14731 DS_ID:19167 EP_NO: N/A Repair Type: Non-Urgent Crossing Status: Found UCIP Comments: Dense vegetation on landward side obstructs inspection. Vegetation needs to be cleared to perform utility crossing inspection. FIELD_STRUCT_DESC: 24-inch corrugated metal drainage pipe through the levee, 12 feet below the crown. Flap gate located on the waterside (WS) end. [Additional Reference(s): DWR Levee Logs, 2005. USACE Sacramento O&M Manual Unit No. 151, November 1953, (Station 0+60)] FS Date: 5/1/2013

View of railroad looking west of crossing.

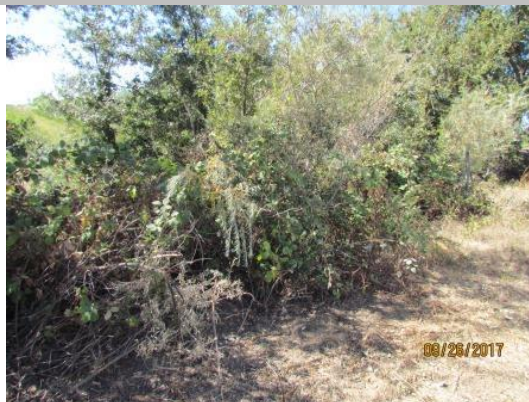
Photo 1 of 1 : SP_2018_NA0006_252_8_20180302_00002.jpg

LM Start	0.02	Rating **	U	Issue No.	8
LM End	0.06	Issue Type +	Ma	Location *	LS
Category	Earthen Levee			GPS Latitude/Longitude	
				Start	End
Item	Vegetation			39.298486 °	39.299052 °
				-121.569504 °	-121.569277 °
DWR ID	DWR_NA0006_01_s_2017_8				
Comment Code					
V2 : Remove the wild growth other than native grasses from the levee slopes.					
Inspector Comment					
Broad leaf thistle and bushes covering landside slope, Fall 2017.

View looking downstream of broad leaf thistle & bushes covering landside slope, Fall 2017.

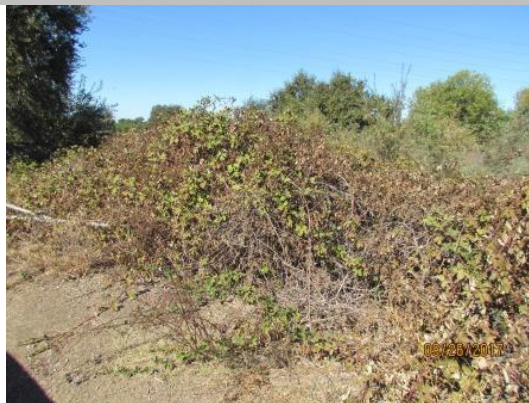
Photo 1 of 1 : SP_2018_NA0006_252_19_20180302_00007.jpg

LM Start	0.02	Rating **	U	Issue No.	19
LM End	0.05	Issue Type +	Ma	Location *	WS
Category	Earthen Levee			GPS Latitude/Longitude	
				Start	End
Item	Vegetation			39.298500 °	39.298995 °
				-121.569508 °	-121.569334 °
DWR ID	DWR_NA0006_01_f_2016_19				
Comment Code					
V2 : Remove the wild growth other than native grasses from the levee slopes.					
Inspector Comment					
Remove Blackberry bushes covering waterside levee slope, Fall 2017.

View of Blackberry bushes covering waterside levee slope, Fall 2017.

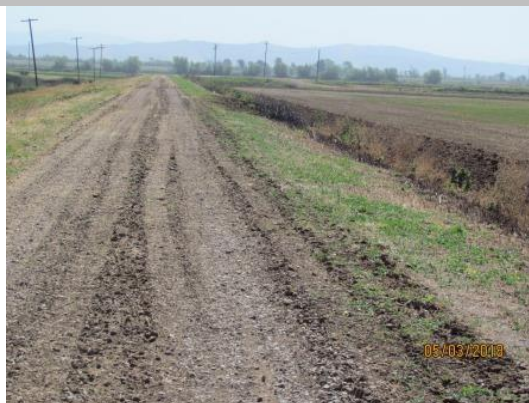
Photo 1 of 1 : SP_2018_NA0006_252_11_20180503_00032.jpg

LM Start	0.02	Rating **	A	Issue No.	11
LM End	0.66	Issue Type +	Ma	Location *	LS
Category	Earthen Levee			GPS Latitude/Longitude	
				Start	End
Item	Vegetation			39.298511 °	39.297595 °
				-121.569505 °	-121.558350 °
DWR ID	DWR_NA0006_01_s_2018_11				
Comment Code					
V1 : Control annual grass and weeds on the levee slopes and easements.					
Inspector Comment					
Annual vegetation is maintained, Spring 2018.

View looking upstream landside of maintained annual vegetation.

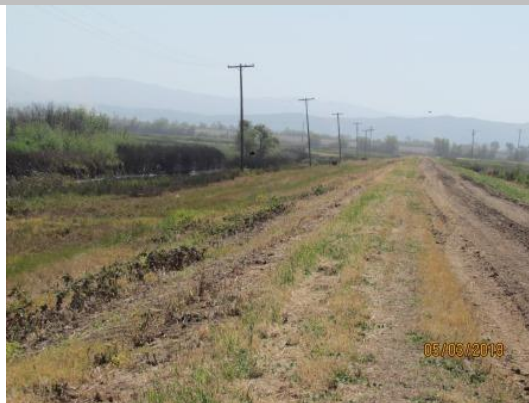
Photo 1 of 1 : SP_2018_NA0006_252_14_20180503_00029.jpg

LM Start	0.02	Rating **	A	Issue No.	14
LM End	0.66	Issue Type +	Ma	Location *	WS
Category	Earthen Levee			GPS Latitude/Longitude	
				Start	End
Item	Vegetation			39.298511 °	39.297595 °
				-121.569505 °	-121.558349 °
DWR ID	DWR_NA0006_01_s_2018_14				
Comment Code					
V1 : Control annual grass and weeds on the levee slopes and easements.					
Inspector Comment					
Annual vegetation is maintained, Spring 2018.

View looking upstream waterside of maintained annual vegetation.

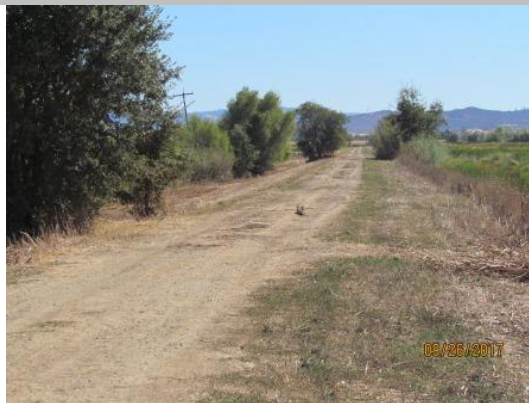
Photo 1 of 1 : SP_2018_NA0006_252_21_20180302_00009.jpg

LM Start	0.02	Rating **	U	Issue No.	21
LM End	0.66	Issue Type +	Ma	Location *	CR
Category	Earthen Levee			GPS Latitude/Longitude	
				Start	End
Item	Crown Surface / Depressions / Rutting			39.298504 °	39.297595 °
				-121.569502 °	-121.558310 °
DWR ID	DWR_NA0006_01_s_2015_21				
Comment Code					
C3 : Add appropriate gravel or road base. Grade and compact.					
Inspector Comment					
Place appropriate gravel on the crown roadway to make it an all weather road, Fall 2017.

View of the crown looking upstream of a section of road that needs all weather surface. Fall 2017.

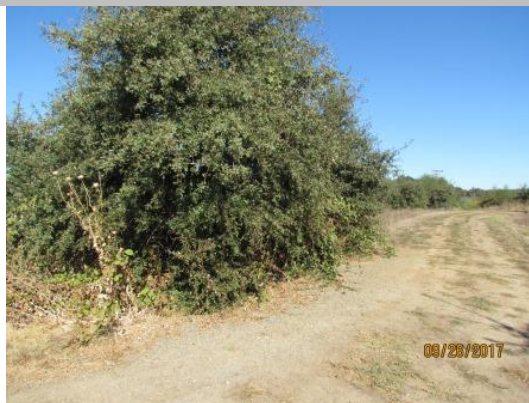
Photo 1 of 1 : SP_2018_NA0006_252_20_20180302_00008.jpg

LM Start	0.02	Rating **	U	Issue No.	20
LM End	0.02	Issue Type +	Ma	Location *	WS
Category	Earthen Levee			GPS Latitude/Longitude	
				Start	End
Item	Trim / Thin Trees			39.298563 °	39.298563 °
				-121.569432 °	-121.569432 °
DWR ID	DWR_NA0006_01_f_2016_20				
Comment Code					
T1 : Trim trees to at least five feet above ground level.					
Inspector Comment					
A tree that needs the limbs trimmed up 5' for visibility and access on the waterside. Fall 2017.

View of a tree that needs the limbs trimmed up 5' for visibility and access on the waterside looking upstream, Fall 2017.

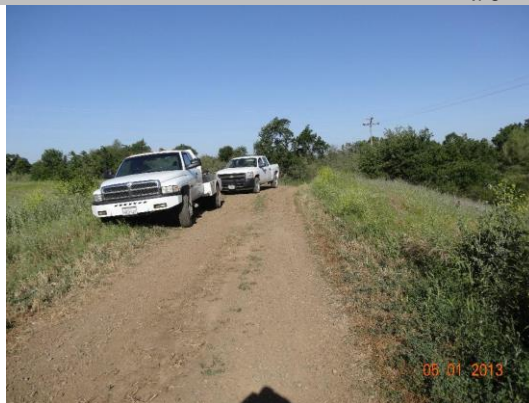
Photo 1 of 3 : UCIP_SP_2018_14732_24241.jpg

LM Start	0.09	Rating **	M	Issue No.	28
LM End	0.09	Issue Type +	Ma	Location *	
Category	Supplemental			GPS Latitude/Longitude	
				Start	End
Item	DWR UCIP LMA Responsibility			39.299106 °	39.299106 °
				-121.568749 °	-121.568749 °
DWR ID					
Comment Code					
Inspector Comment					
FS_ID:14732 DS_ID:19168 EP_NO: N/A Repair Type: Non-Urgent Crossing Status: Found UCIP Comments: Dense vegetation on waterward side and landward side obstructs inspection. Need to clear vegetation on slopes to conduct proper crossing evaluation. FIELD_STRUCT_DESC: 24-inch corrugated metal drainage pipe through the levee, 10 feet below the crown. Flap gate located on the waterside (WS) end. [Additional Reference(s): DWR Levee Logs, 2005. USACE Sacramento O&M Manual Unit No. 151, November 1953, (Station 5+65)] FS Date: 5/1/2013

Overview of levee crown at crossing looking upstream.

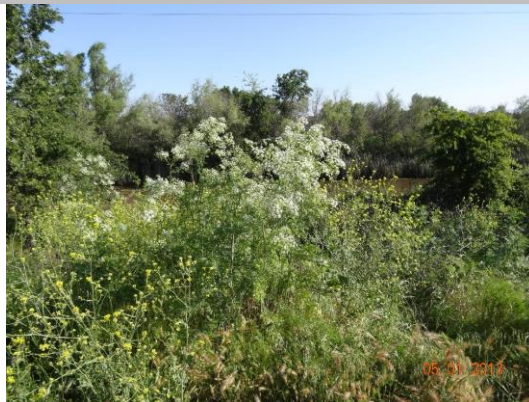
Photo 2 of 3 : UCIP_SP_2018_14732_24236.jpg

Dense vegetation obstructing waterward slope.

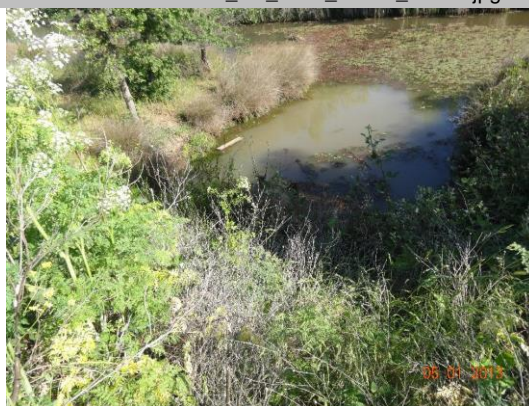
Photo 3 of 3 : UCIP_SP_2018_14732_24238.jpg

LM Start	0.09	Rating **	M	Issue No.	28 (cont)	
LM End	0.09	Issue Type +	Ma	Location *		
Category	Supplemental			GPS Latitude/Longitude		
				Start		End
Item	DWR UCIP LMA Responsibility			39.299106 °		39.299106 °
				-121.568749 °		-121.568749 °
DWR ID						
Comment Code						
Inspector Comment						
FS_ID:14732 DS_ID:19168 EP_NO: N/A Repair Type: Non-Urgent Crossing Status: Found UCIP Comments: Dense vegetation on waterward side and landward side obstructs inspection. Need to clear vegetation on slopes to conduct proper crossing evaluation. FIELD_STRUCT_DESC: 24-inch corrugated metal drainage pipe through the levee, 10 feet below the crown. Flap gate located on the waterside (WS) end. [Additional Reference(s): DWR Levee Logs, 2005. USACE Sacramento O&M Manual Unit No. 151, November 1953, (Station 5+65)] FS Date: 5/1/2013

Overview of waterward side (outlet).

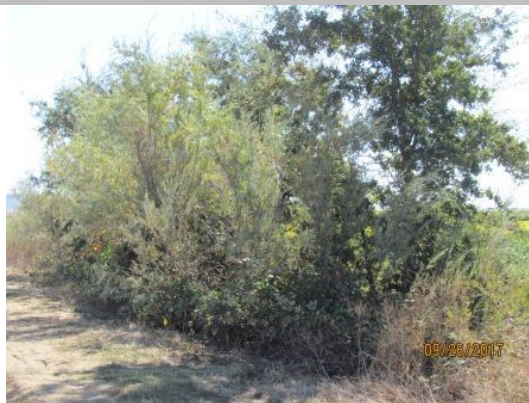
Photo 1 of 1 : SP_2018_NA0006_252_23_20180302_00011.jpg

LM Start	0.21	Rating **	U	Issue No.	23
LM End	0.21	Issue Type +	Ma	Location *	LS
Category	Earthen Levee			GPS Latitude/Longitude	
				Start	End
Item	Trim / Thin Trees			39.298816 °	39.298816 °
				-121.566529 °	-121.566529 °
DWR ID	DWR_NA0006_01_f_2016_23				
Comment Code					
T3 : Trim and thin trees to allow visibility of the ground and room to flood fight.					
Inspector Comment					
Trees that needs the limbs trimmed up 5' for visibility and access on the landside. Fall 2017.

View looking upstream landside of trees that needs the limbs trimmed up 5' for visibility and access on the landside, Fall 2017.

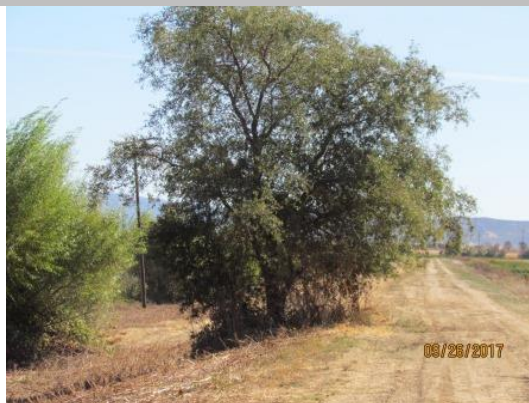
Photo 1 of 1 : SP_2018_NA0006_252_25_20180302_00012.jpg

LM Start	0.23	Rating **	M	Issue No.	25	
LM End	0.23	Issue Type +	Ma	Location *	WS	
Category	Earthen Levee			GPS Latitude/Longitude		
				Start		End
Item	Trim / Thin Trees			39.298776 °		39.298776 °
				-121.566158 °		-121.566158 °
DWR ID	DWR_NA0006_01_f_2016_25					
Comment Code						
T1 : Trim trees to at least five feet above ground level.						
Inspector Comment						
Tree that needs the limbs trimmed up 5' for visibility and access on the waterside. Fall 2017.

View looking upstream waterside of a tree that needs the limbs trimmed up 5' for visibility and access on the waterside, Fall 2017.

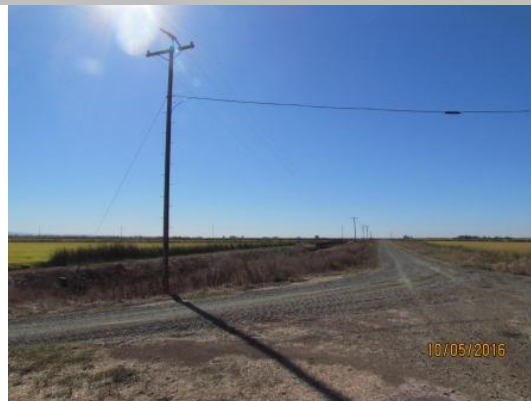
Photo 1 of 1 : SP_2018_NA0006_252_17_20180302_00006.jpg

LM Start	0.66	Rating **	M	Issue No.	17
LM End	1.45	Issue Type +	En	Location *	WS
Category	Earthen Levee			GPS Latitude/Longitude	
				Start	End
Item	Encroachments			39.297629 °	39.295257 °
				-121.558337 °	-121.546579 °
DWR ID	DWR_NA0006_01_s_2015_17				
Comment Code					
PO : Pole					
Inspector Comment

View of the poleline on the waterside of the levee facing upstream. Fall 2016.

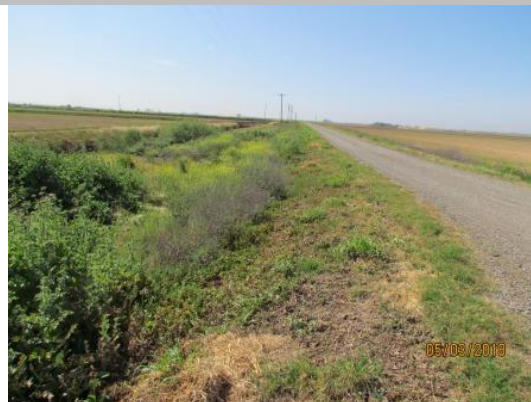
Photo 1 of 1 : SP_2018_NA0006_252_13_20180503_00034.jpg

LM Start	0.66	Rating **	U	Issue No.	13
LM End	1.45	Issue Type +	Ma	Location *	WS
Category	Earthen Levee			GPS Latitude/Longitude	
				Start	End
Item	Vegetation			39.297604 °	39.295250 °
				-121.558325 °	-121.546604 °
DWR ID	DWR_NA0006_01_f_2017_13				
Comment Code					
V1 : Control annual grass and weeds on the levee slopes and easements.					
Inspector Comment					
Annual vegetation needs to be maintained, Spring 2018.

View looking upstream waterside of annual vegetation that needs to be maintained.

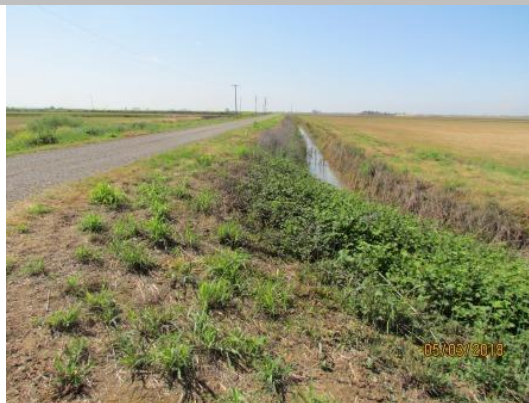
Photo 1 of 1 : SP_2018_NA0006_252_12_20180503_00033.jpg

LM Start	0.67	Rating **	U	Issue No.	12
LM End	1.45	Issue Type +	Ma	Location *	LS
Category	Earthen Levee			GPS Latitude/Longitude	
				Start	End
Item	Vegetation			39.297510 °	39.295259 °
				-121.558330 °	-121.546684 °
DWR ID	DWR_NA0006_01_s_2018_12				
Comment Code					
V1 : Control annual grass and weeds on the levee slopes and easements.					
Inspector Comment					
Annual vegetation needs to be maintained, Spring 2018.

View looking upstream landside of annual vegetation that needs to be maintained.

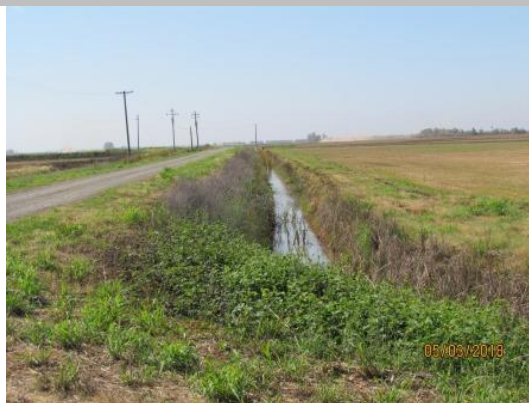
Photo 1 of 1 : SP_2018_NA0006_252_15_20180503_00035.jpg

LM Start	0.68	Rating **	M	Issue No.	15
LM End	1.45	Issue Type +	En	Location *	LS
Category	Earthen Levee			GPS Latitude/Longitude	
				Start	End
Item	Encroachments			39.297426 °	39.295260 °
				-121.558319 °	-121.546719 °
DWR ID	DWR_NA0006_01_s_2018_15				
Comment Code					
DT : Ditch					
Inspector Comment					
Landside levee ditch.

View looking upstream of landside ditch at levee toe.

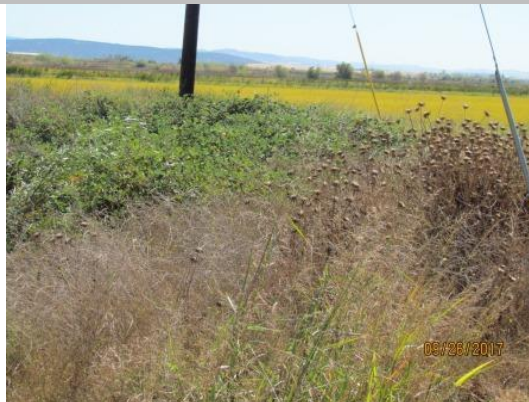
Photo 1 of 1 : SP_2018_NA0006_252_1_20180302_00001.jpg

LM Start	0.85	Rating **	U	Issue No.	1
LM End	0.96	Issue Type +	Ma	Location *	WS
Category	Earthen Levee			GPS Latitude/Longitude	
				Start	End
Item	Vegetation			39.294995 °	39.295021 °
				-121.557823 °	-121.555813 °
DWR ID	DWR_NA0006_01_f_2016_1				
Comment Code					
V2 : Remove the wild growth other than native grasses from the levee slopes.					
Inspector Comment					
Remove Blackberry bushes starting to take over waterside slope. Spring 2017.

View of Blackberry bushes that are starting to cover the waterside slope. Looking upstream waterside, Fall 2017.

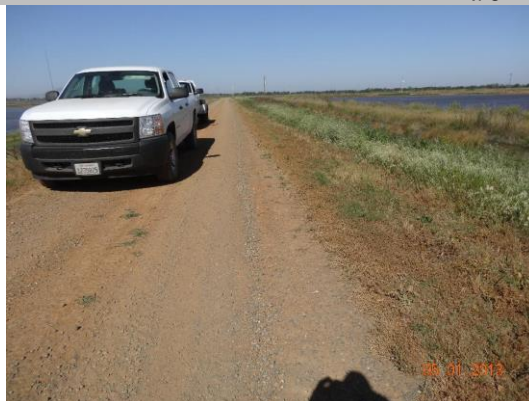
Photo 1 of 3 : UCIP_SP_2018_14733_24253.jpg

Comment Code						
Inspector Comment						
FS_ID:14733 DS_ID:19172 EP_NO: 9610 Repair Type: Non-Urgent Crossing Status: Found UCIP Comments: Scouring occuring directly across pipe on access road. Need to determine permit authorizing updates to crossing. Crossing appears to be no more than 10 years old. FIELD_STRUCT_DESC: 1 of 2: 24-inch corrugated metal irrigation pipe through the levee, 6 feet below the crown. Slide gates are installed on waterside (WS) end of pipe. (two 24-inch pipe authorized Permit No. 9610, 1974-Honcut Creek Ranch). [Additional Reference(s): DWR Levee Logs, 2005. USACE Sacramento O&M Manual Unit No. 151, November 1953, (Station 53+70)] FS Date: 5/1/2013

Overview of levee crown looking upstream at crossing.

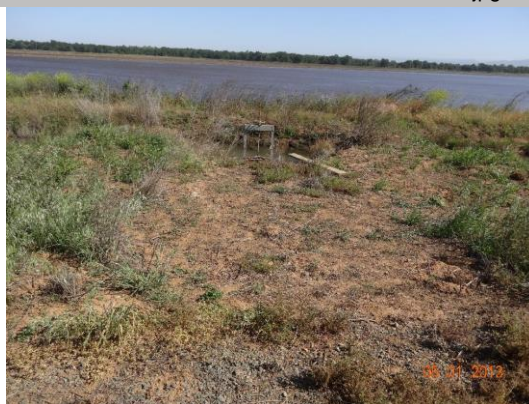
Photo 2 of 3 : UCIP_SP_2018_14733_24252.jpg

View of waterward side.

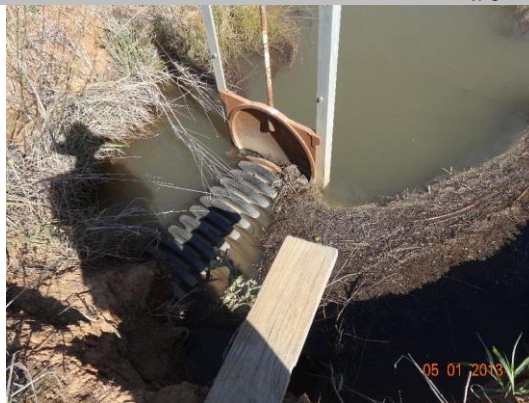
Photo 3 of 3 : UCIP_SP_2018_14733_24251.jpg

Comment Code						
Inspector Comment						
FS_ID:14733						
DS_ID:19172						
EP_NO: 9610						
Repair Type: Non-Urgent						
Crossing Status: Found						
UCIP Comments: Scouring occuring directly across pipe on access road. Need to determine permit authorizing updates to crossing.						
Crossing appears to be no more than 10 years old.						
FIELD_STRUCT_DESC: 1 of 2: 24-inch corrugated metal irrigation pipe through the levee, 6 feet below the crown. Slide gates are installed on waterside (WS) end of pipe. (two 24-inch pipe authorized Permit No. 9610, 1974-Honcut Creek Ranch). [Additional Reference(s): DWR Levee Logs, 2005. USACE Sacramento O&M Manual Unit No. 151, November 1953, (Station 53+70)]						
FS Date: 5/1/2013

Positive closure device on waterward side.

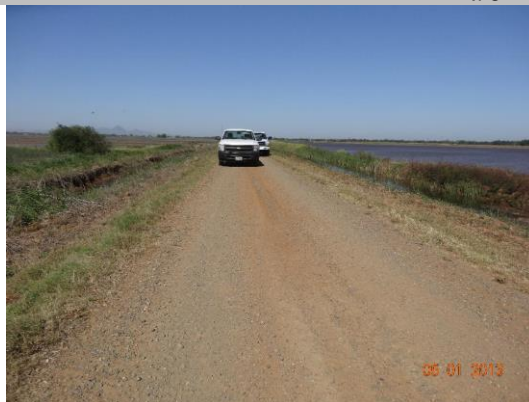
Photo 1 of 3 : UCIP_SP_2018_14734_24259.jpg

LM Start	1.17	Rating **	M	Issue No.	30
LM End	1.17	Issue Type +	En	Location *	
Category	Supplemental			GPS Latitude/Longitude	
				Start	End
Item	DWR UCIP Field Study			39.295099 °	39.295099 °
				-121.551839 °	-121.551839 °
DWR ID					
Comment Code					
Inspector Comment					
FS_ID:14734 DS_ID:19174 EP_NO: N/A Repair Type: Non-Urgent Crossing Status: Found UCIP Comments: Recent repair will need to contact owner to follow-up. FIELD_STRUCT_DESC: 24-inch corrugated metal drainage pipe through the levee, 10 feet below the crown. Flap gate located on the waterside (WS). FS Date: 5/1/2013

Overview of levee crown looking upstream from crossing.

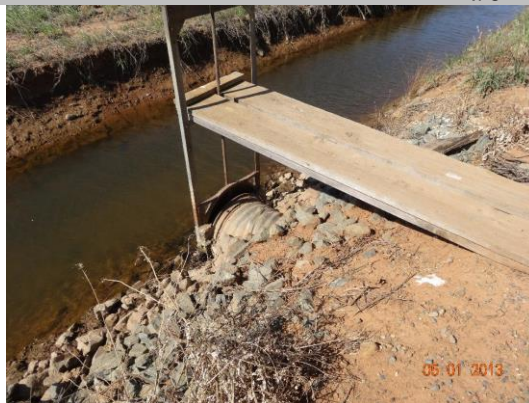
Photo 2 of 3 : UCIP_SP_2018_14734_24258.jpg

LM Start	1.17	Rating **	M	Issue No.	30 (cont)
LM End	1.17	Issue Type +	En	Location *	
Category	Supplemental			GPS Latitude/Longitude	
				Start	End
Item	DWR UCIP Field Study			39.295099°	39.295099°
				-121.551839°	-121.551839°
DWR ID					
Comment Code					
Inspector Comment					
FS_ID:14734 DS_ID:19174 EP_NO: N/A Repair Type: Non-Urgent Crossing Status: Found UCIP Comments: Recent repair will need to contact owner to follow-up. FIELD_STRUCT_DESC: 24-inch corrugated metal drainage pipe through the levee, 10 feet below the crown. Flap gate located on the waterside (WS). FS Date: 5/1/2013

View of landward side: positive closure device, walkway, and rip rap on slope.

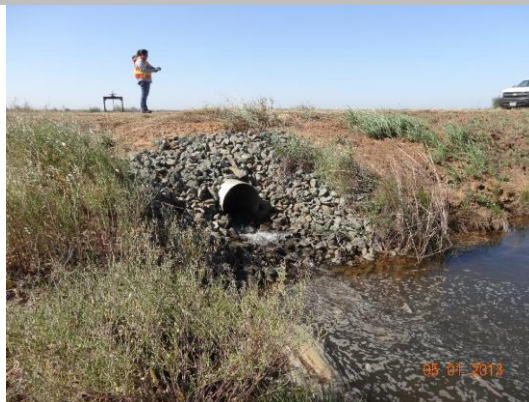
Photo 3 of 3 : UCIP_SP_2018_14734_24257.jpg

View of waterward side crossing looks fairly new.

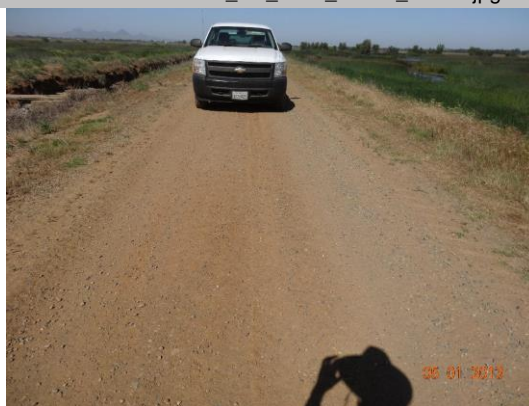
Photo 1 of 3 : UCIP_SP_2018_14736_24275.jpg

LM Start	1.44	Rating **	M	Issue No.	31	
LM End	1.44	Issue Type +	En	Location *		
Category	Supplemental			GPS Latitude/Longitude		
				Start	End	
Item	DWR UCIP Field Study			39.295238 °	39.295238 °	
				-121.546755 °	-121.546755 °	
DWR ID						
Comment Code						
Inspector Comment						
FS_ID:14736						
DS_ID:19169						
EP_NO: N/A						
Repair Type: Non-Urgent						
Crossing Status: Found						
UCIP Comments: Need to determine permit authorizing work.						
FIELD_STRUCT_DESC: 18-inch corrugated metal irrigation pipe						
through the levee, 8 feet below the crown. Slide gate located on the						
landside (LS) end. Rock revetment on the LS near slide-gate.						
[Additional Reference(s): DWR Levee Logs, 2005]						
FS Date: 5/1/2013

View of levee crown looking upstream at crossing.

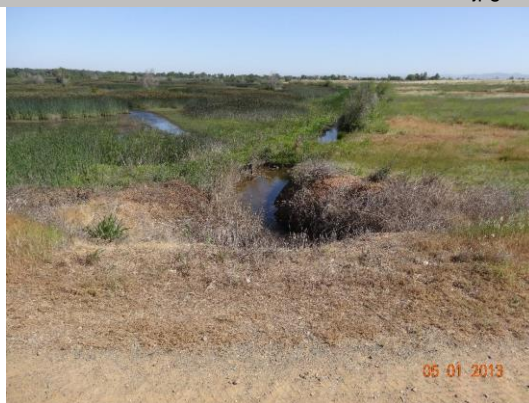
Photo 2 of 3 : UCIP_SP_2018_14736_24272.jpg

View of waterward side.

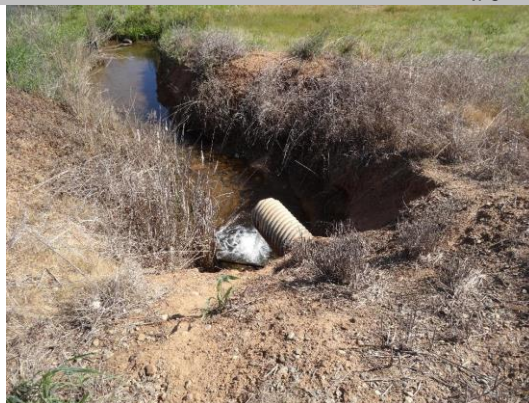
Photo 3 of 3 : UCIP_SP_2018_14736_24274.jpg

LM Start	1.44	Rating **	M	Issue No.	31 (cont)	
LM End	1.44	Issue Type +	En	Location *		
Category	Supplemental			GPS Latitude/Longitude		
				Start	End	
Item	DWR UCIP Field Study			39.295238 °	39.295238 °	
				-121.546755 °	-121.546755 °	
DWR ID						
Comment Code						
Inspector Comment						
FS_ID:14736						
DS_ID:19169						
EP_NO: N/A						
Repair Type: Non-Urgent						
Crossing Status: Found						
UCIP Comments: Need to determine permit authorizing work.						
FIELD_STRUCT_DESC: 18-inch corrugated metal irrigation pipe						
through the levee, 8 feet below the crown. Slide gate located on the						
landside (LS) end. Rock revetment on the LS near slide-gate.						
[Additional Reference(s): DWR Levee Logs, 2005]						
FS Date: 5/1/2013

Crossing visible on waterward side.
